BRADEN ROOFING NEWS

Vol. 2

COMPOSITION SHINGLE HAIL DAMAGE

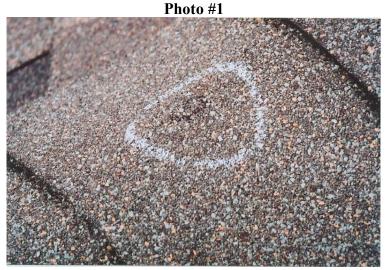
Hail often damages ridge shingles.

The first place to look for hail damage on any roof is on the vents and ridges. Ridges are especially prone to damage (see photo #1).

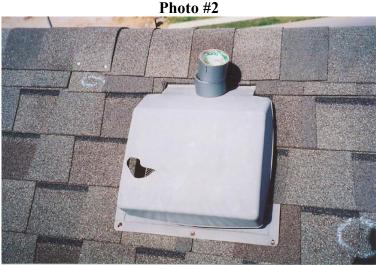
Hail hits can leave large leak-prone holes in vents. Duct tape can provide a quick emergency repair.

Frequently, vents will be damaged by hail hits. Dents in metal vents are a good hint that the entire roof needs to be closely examined for hail hits. Plastic vents will frequently shatter, leaving big, gaping holes (see photo #2). Not only do these holes indicate hail damage, but they also indicate the need for a quick emergency repair.

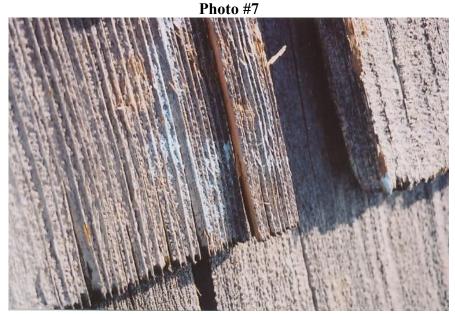
This is the same shingle as in Photo #6 with the crack now easily seen. This kind of crack is often missed by adjusters and roofers alike.

Rare, indeed, is the insurance adjustor who takes time to feel every darn shingle in a Haag square. Many don't even get on the rooftop. At Braden Roofing, we feel that visual inspection, even from the rooftop, is not adequate to accurately gauge hail damage. Observe photo #7. This is the same shingle as in photo #6, with the crack physically separated out for easy observation.

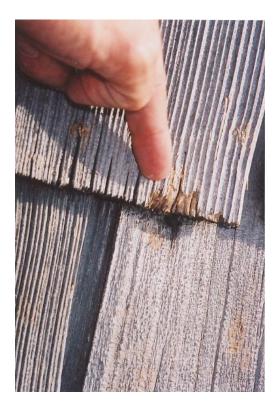
Photo #9
Butt rot hits still count if fresh wood is exposed.

Photo #9 shows what is commonly referred to as a "butt rot hit" (no, I am not making this up!). This is the most controversial of hail hits.

First of all, the lowest edge (butt end) of a shake shingle, as it ages, begins to deteriorate and soften faster than the rest of the shingle. As such, a hail hit on this part of the shingle will tend to break the wood more easily. In the past, many insurance companies have rejected this hit in their Haag count. However, most insurance companies will now count a butt rot hit IF fresh (orange) wood is exposed. Photo #9 shows a shingle that we feel should qualify under Haag.

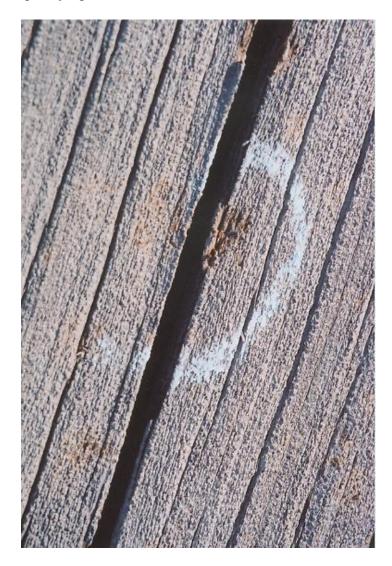
Photo #10

This hit qualifies for HAAG, because fresh wood is exposed.

Sometimes, a customer may ask us if hail damage really shortens the life of a roof. Generally speaking, the answer is yes, as split shingles expose the felt underlayment of a shake roof to more weathering. Sometimes a legitimate hail hit as defined by Haag will not truly shorten the life of a roof, as in photo #10. In this picture, we see that a hail hit has torn the edge of the shingle, exposing fresh wood, and thus, qualifying for Haag. Will this hit (all other things being equal) shorten the life of this roof? Probably, but not by itself though. Nonetheless, we should still count this as a hit per Haag. Most Haag qualifying hail hits, however, do indeed shorten the life of a roof.

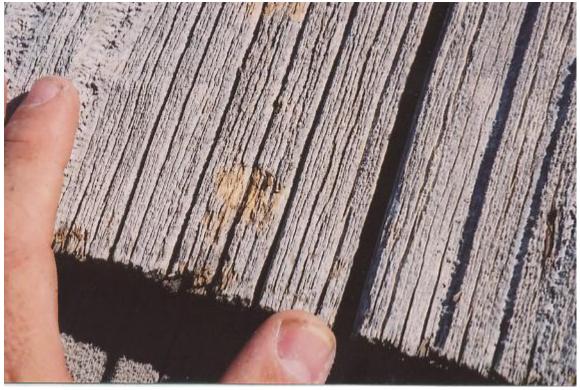
Age related cracks do not qualify as hail damage.

Please note that not all cracks in shake shingles are caused by hail. Shake shingles will frequently crack due to age and weathering. Such damage, while certainly a problem for a wood shake roof, does NOT qualify as hail damage under Haag guidelines. Photo #11 shows a shake shingle which has been clobbered by hail, and also has concurrent cracks. However, it is obvious that the cracks were due to weathering, not hail. This is not considered hail related damage.
