Braden Roofing News Vol. 1

Everything you ever wanted to know about shake spot repairs (but were afraid to ask)

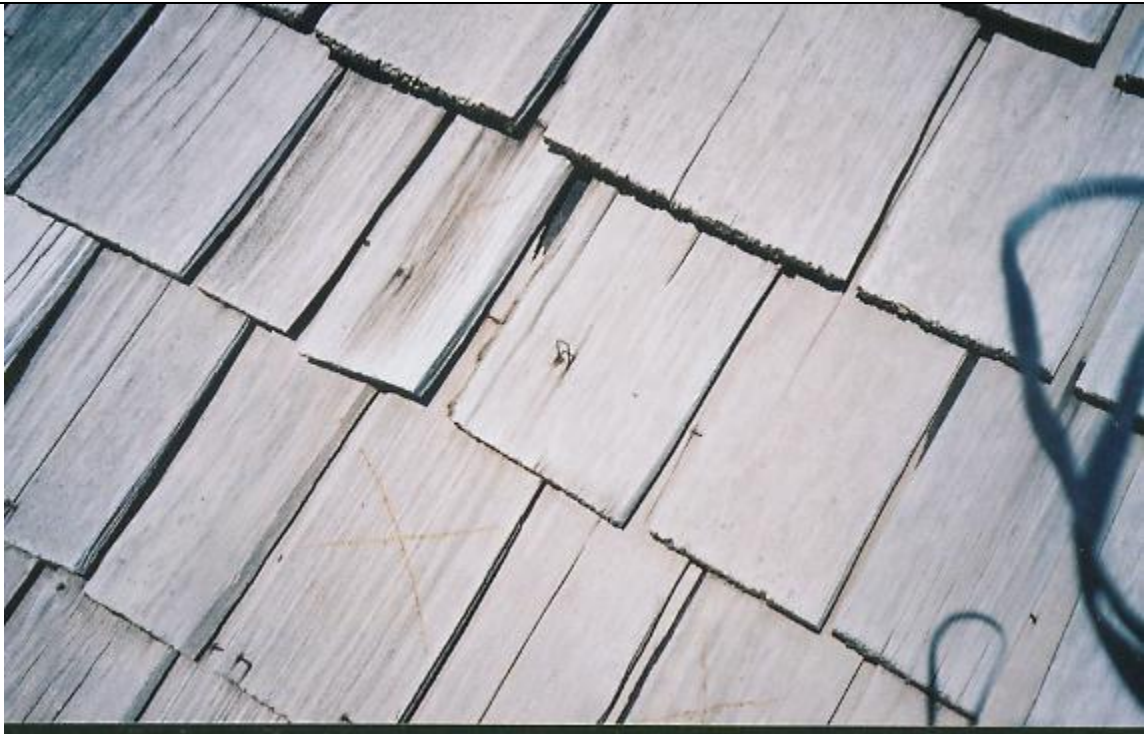
Photo #1

Rain, hail, and wind can all take a toll on a wood shake roof, but the most devastating antagonist to a wood shake roof is sunlight. Sunlight burns up the cell structure of wood, which makes the wood shakes thinner. Eventually, the shake might thin through completely exposing the black felt paper underneath. This almost always happens on the upper part of the shake where it is thinner AND exposed to sunlight between the two shingles of the next course up (SEE PHOTO #1). Left exposed, the felt paper will eventually deteriorate and allow water into the house.

Shake shingle burn-out

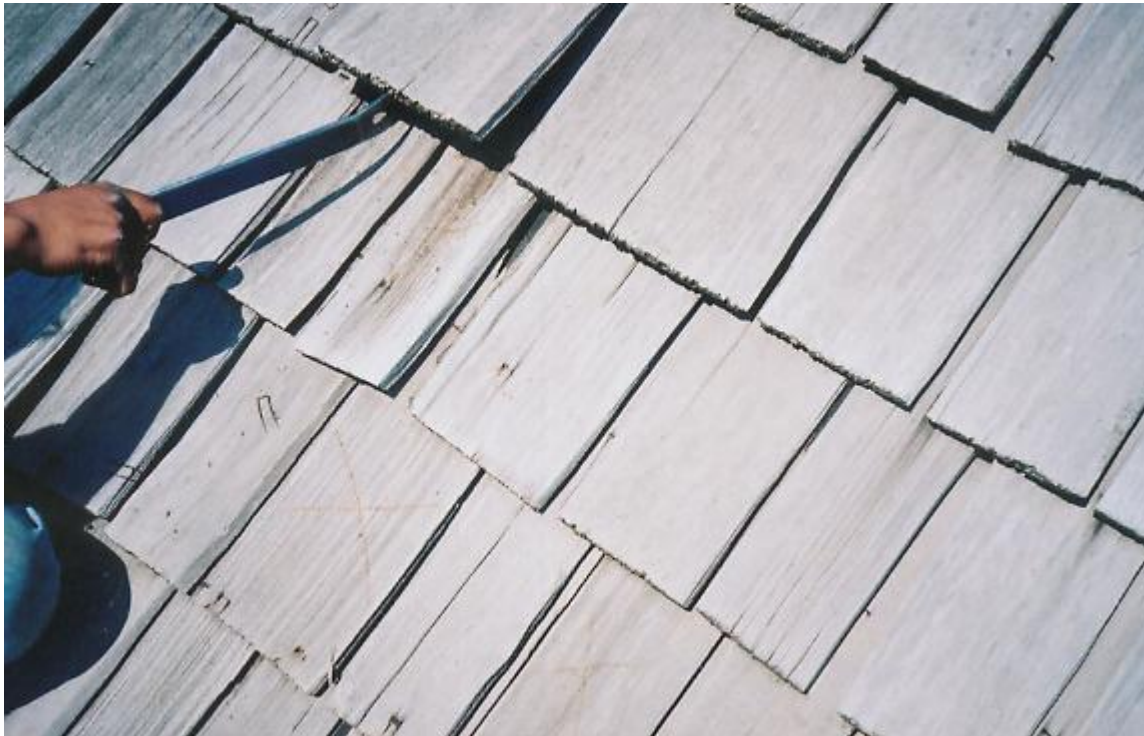
Photo #2

Removing fasteners

A quality roofer will CAREFULLY remove the offending shingle, WITHOUT damaging the other shingles immediately adjacent. Often this requires some finesse, as each shingle may have fasteners from many other shingles penetrating, which must be removed from UNDERNEATH (SEE PHOTO# 2). This is where many roofers will break sometimes 3 or 4 other shingles for every one they replace. If this happens when you are paying for spot-repairs on a per-shingle or per-bundle basis, you will NOT get your money's worth. Extraneous breaks (in adjacent shingles) do happen, even with top quality repair persons (such as those at Braden Roofing!), but they should be kept to a minimum.

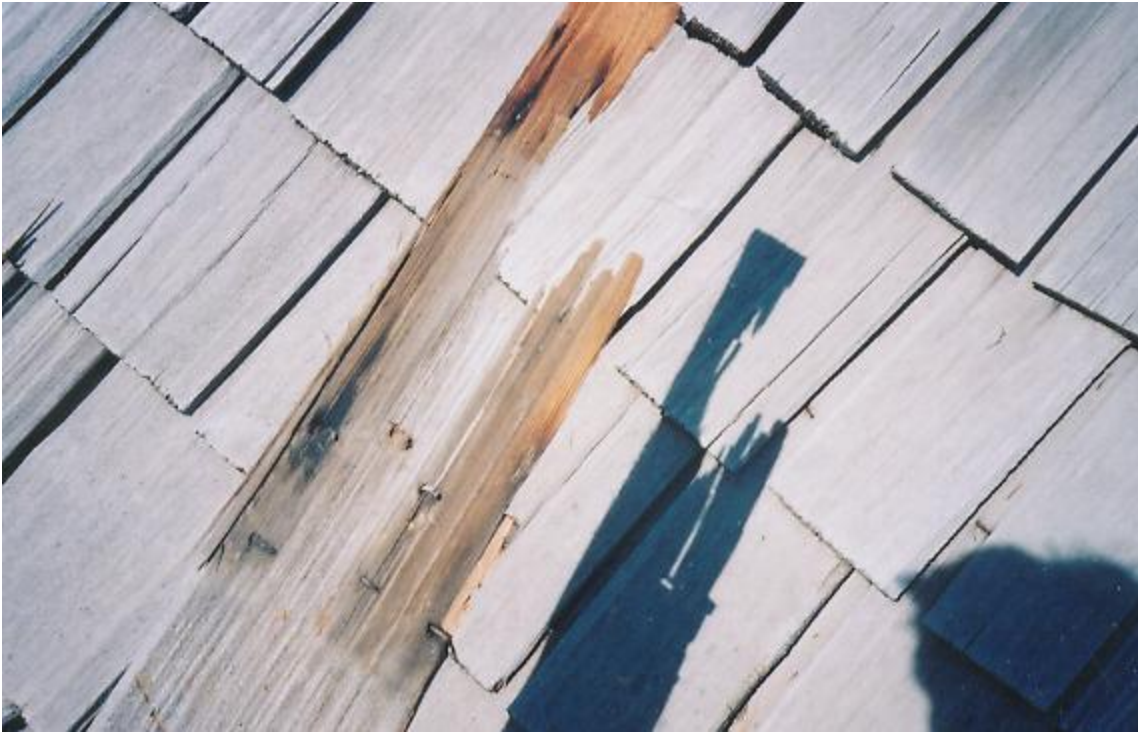
Photo #3 shows what a burned out shingle looks like. Notice in the shingle's shadow how much of the shingle has been vaporized by long-term exposure to sunlight. Lovely, isn't it?

Close-up of a burned out shingle. Notice the shadow. Lovely, isn't it?

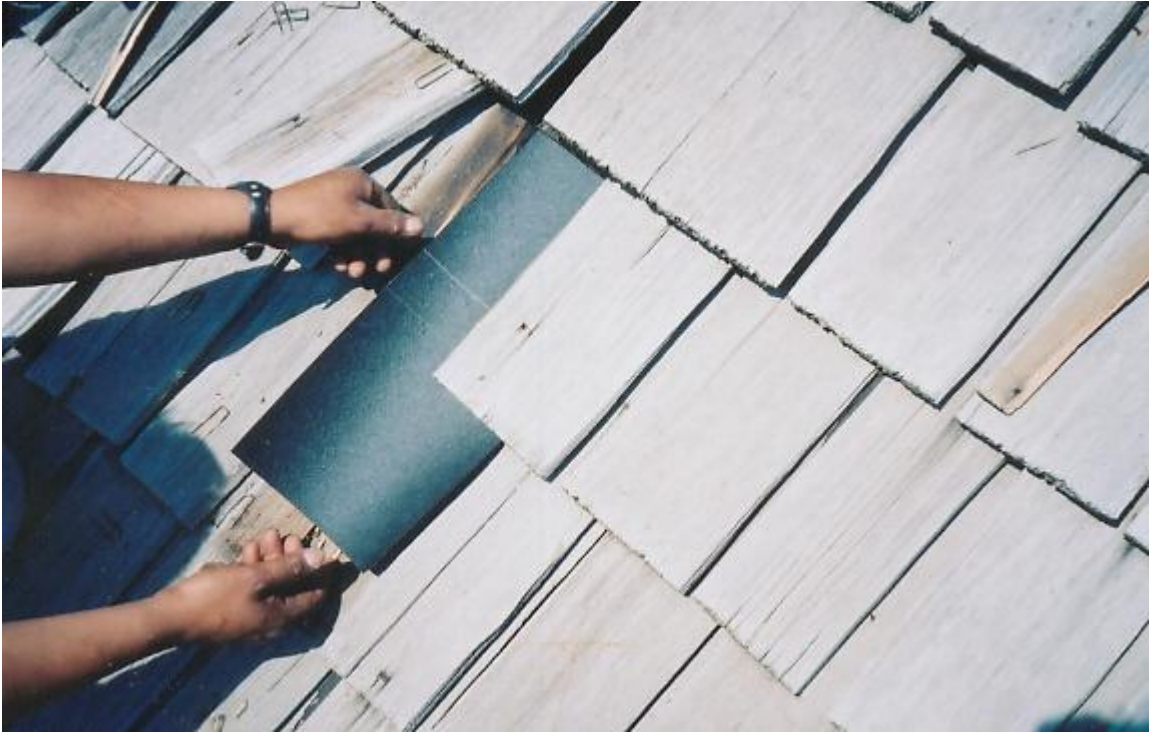
Photo #4

Another surprising discrepancy in repairs involves felt paper (the black tarpaper basesheet). Quality roofers will splice in new felt paper with every shingle replaced (SEE PHOTO #4). This just makes sense because it is the felt paper, after all, which keeps water out of the house. Yet most roofers DO NOT splice in new felt paper. I have seen perfectly good roofs start to leak AFTER the repair work has been completed! Call me crazy, but I always thought that a roof is supposed to leak BEFORE the repair work is done and shed water AFTERWARDS, not vice versa! A quality spot-repair must include new felt paper.

Felt paper splice

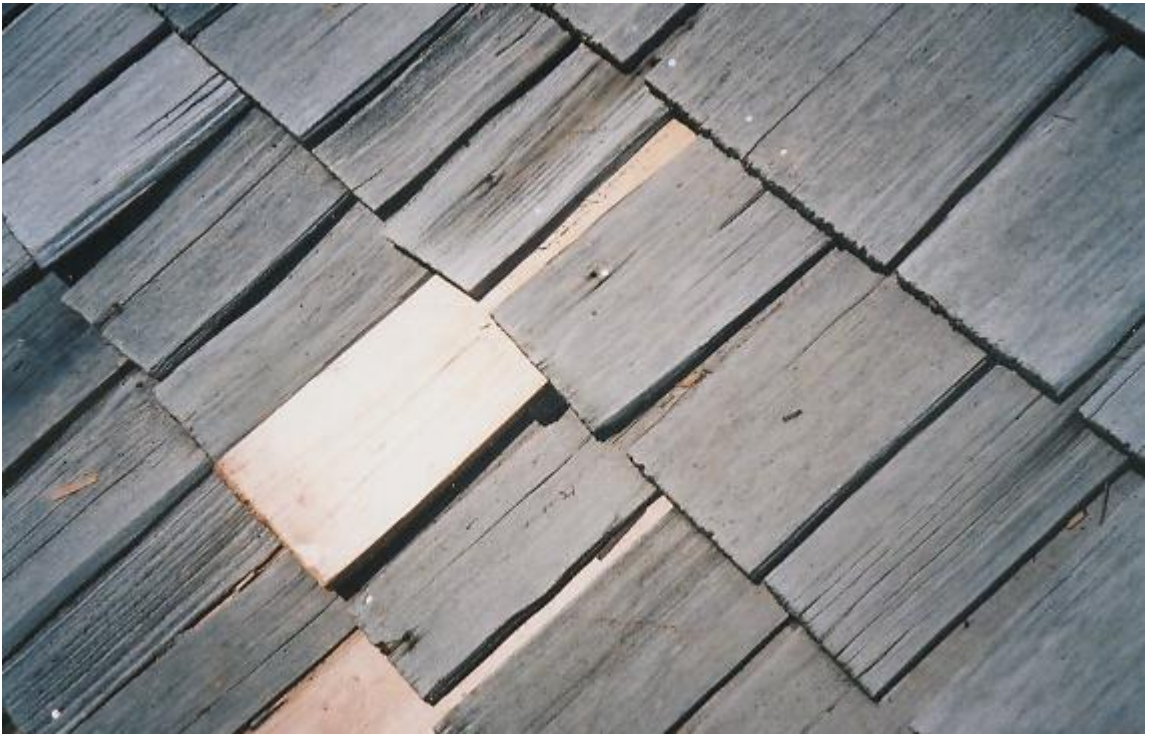
Photo #5

All done, and done right!!

When the spot-repair is finally completed, a shiny new orange-colored shingle now takes the place of the old deteriorated shingle. Felt paper has been spliced in with the shingle, and no adjacent shingles have been damaged (SEE PHOTO #5).
